REPORT OF INVESTIGATION

Fatal Fall of Person Accident
January 14, 2022

NexGen Industrial Services Inc. (A2537)
Mount Morris, Pennsylvania

Ohio County Mine
Ohio County Coal Resources, Inc.
Dallas, Marshall County, West Virginia
ID No. 46-01436

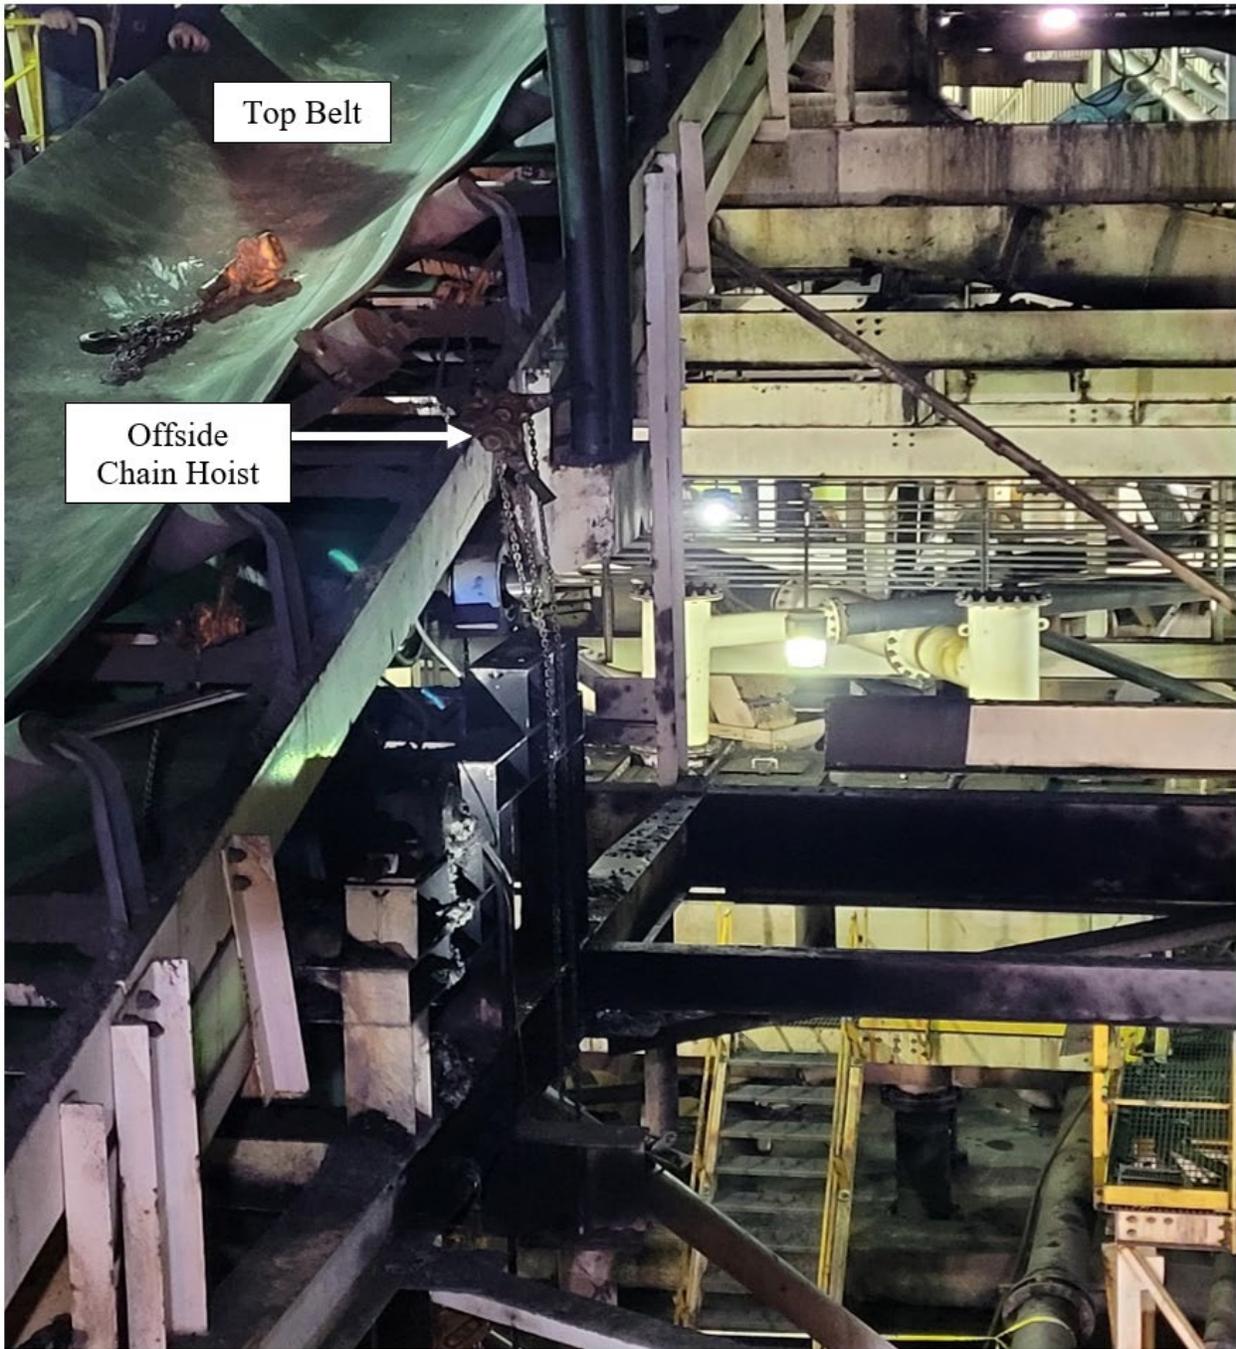
APPENDIX A – 400 Belt

In an interview, Douglas stated that both he and Phillips used fall protection two separate times earlier in the shift. As Phillips was climbing on the top belt to operate the offside chain hoist (see Appendix A), Douglas, standing on the catwalk (see Appendix B) right beside Phillips, told him twice to put on his fall protection. However, Phillips did not put on his fall protection. A short time later, Douglas bent down to see how high Phillips would have to hoist the roller, saw Phillips fall from the 400 belt to the fourth floor, and yelled out. Husner was on the fifth floor, preparing oxygen and acetylene tanks for use, when he heard Douglas yell. Husner turned and saw Phillips lying on the concrete floor.

The accident occurred along the 400 belt inside the preparation plant. The 400 belt travels up from the fifth floor towards the sixth floor. The work area from where the victim fell was 27 feet above the fourth floor. The area was well lit, and there were no moving obstacles above the belt. The distance between the railing and the chain hoist lever was 30 inches. The belt was dry at the time of the accident. The mine operator had idled the plant on the previous shift because the snub roller malfunctioned. NexGen contractors were the only miners present at the accident scene when the accident occurred.
